# SAFETY ACCIDENT REPORT

## **Safety Investigation Report on the Collision of MV Mojaito, Road Harbour, Virgin Islands 26<sup>th</sup> July, 2025**

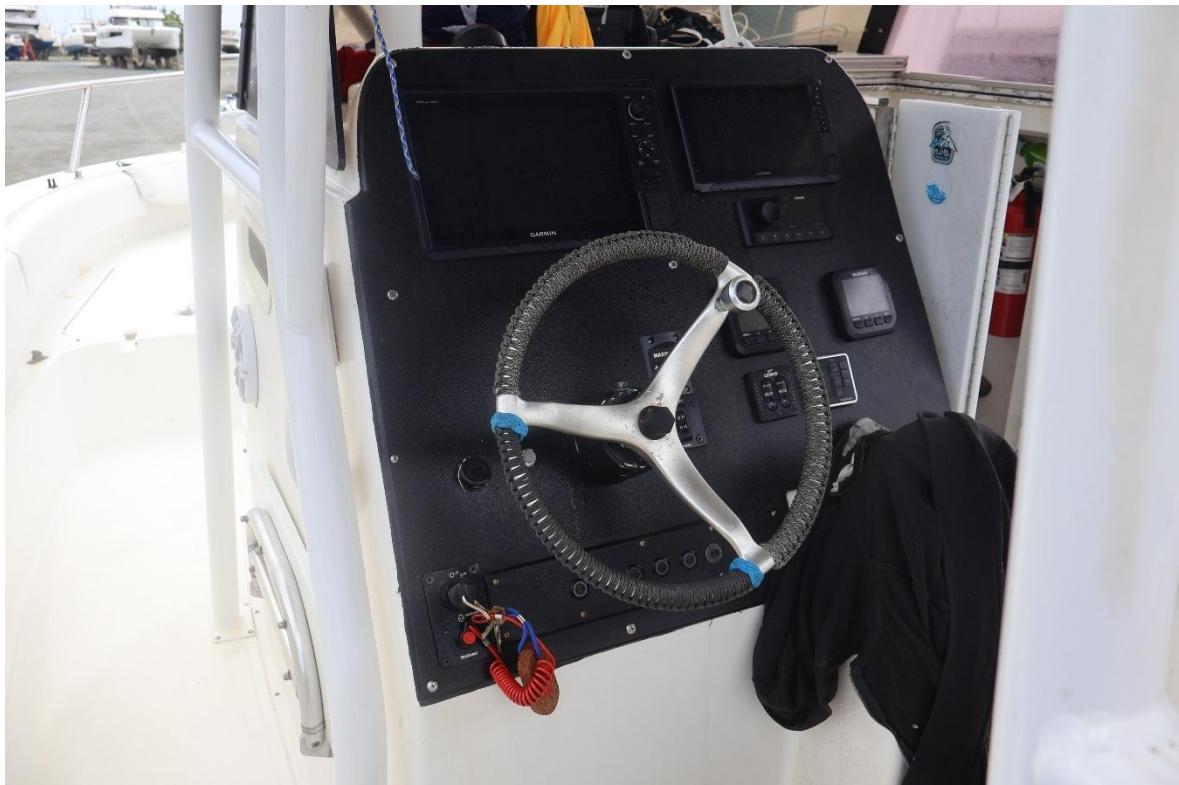
The vessel's kill cord was connected to the kill switch at the helm; it was not secured to the operator at the time of the accident.

Figure 5: Kill cord connected to Kill switch and console.

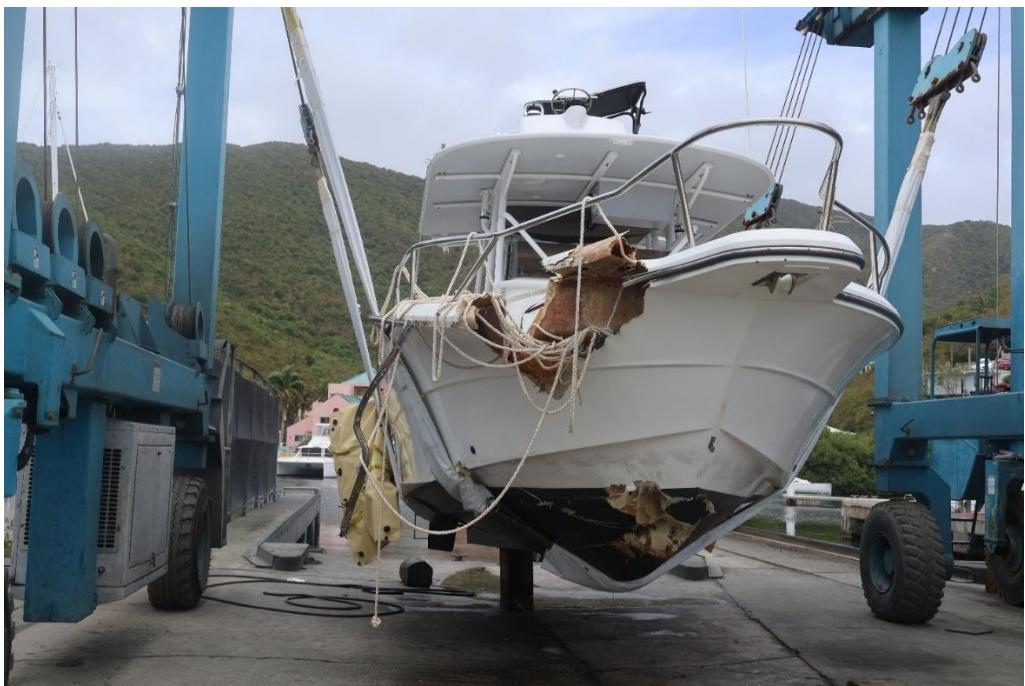
- The vessel sustained severe structural damage concentrated on the forward starboard bow, identified as the primary impact area.
- The stem was torn open from the waterline downward by approximately 2 feet, creating the principal point of uncontrolled water ingress.

Figure 6: Severe damage to the bow as a result of the collision.

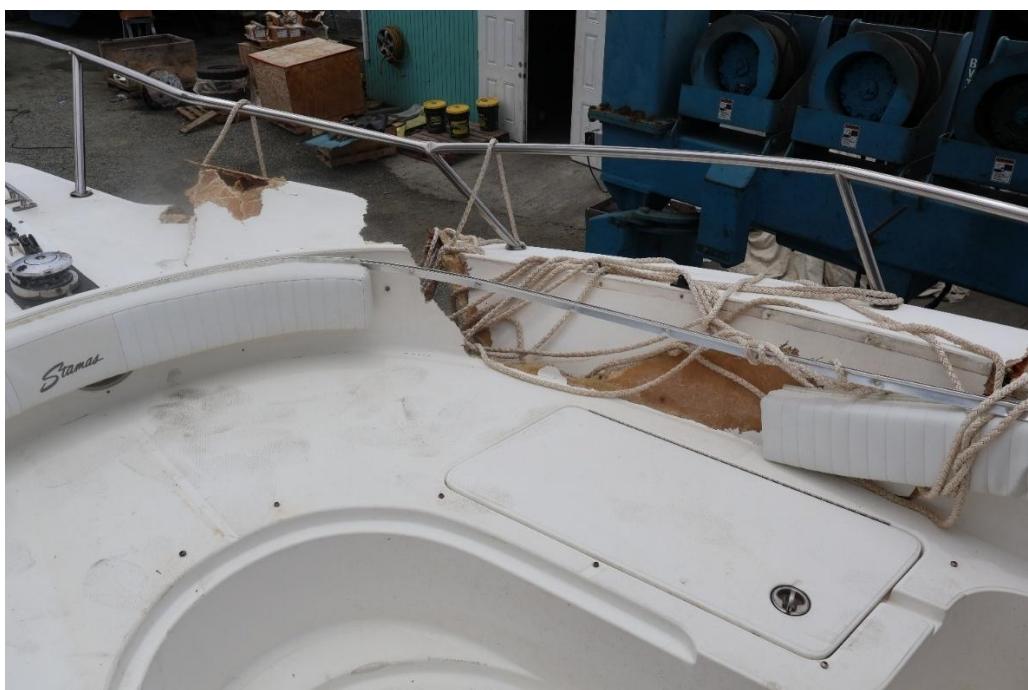
Figure 7: Damaged foredeck and railing

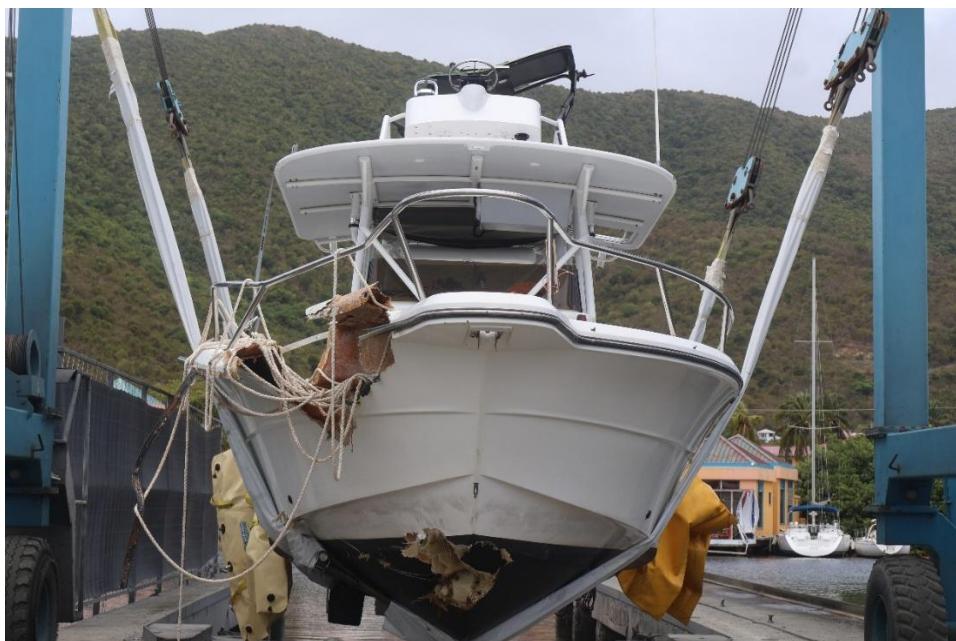
Figure 8: Front view of damaged vessel.

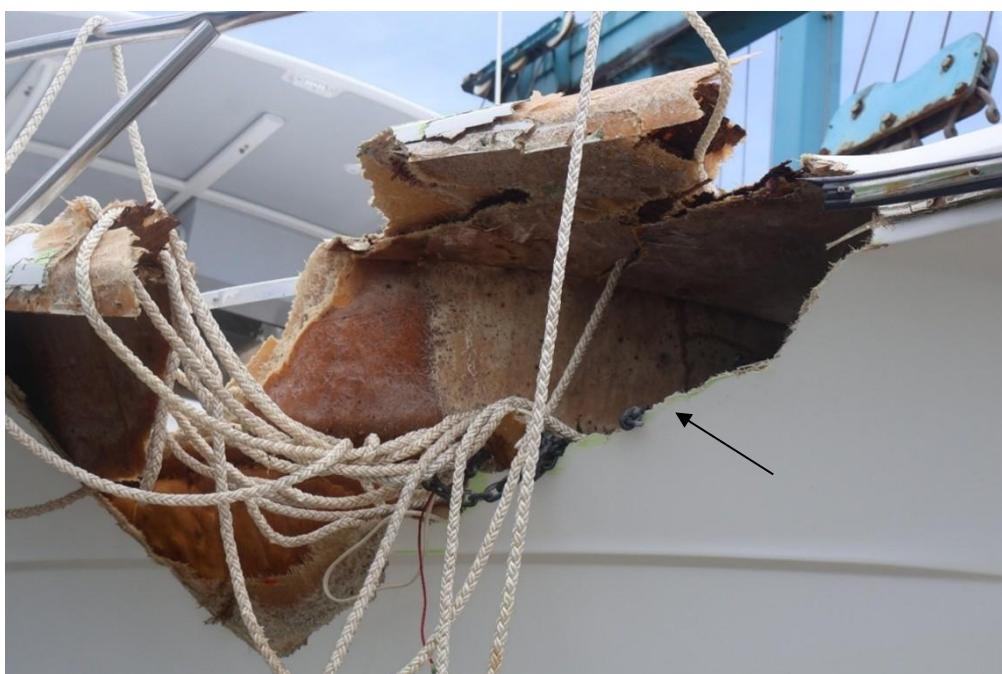
During the inspection of the ship's starboard bow, green paint transfer was observed on several damaged areas of the hull. The colour and texture matched the green buoy. The paint showed a pattern from the impact, with more paint near the main point of contact and less toward the back. This suggests a glancing collision rather than a direct hit. The matching paint provides clear evidence that the damage to Mojaito is linked to the channel marker.

Figure 9: Green paint transfer observed along the damaged areas of the hull, consistent with the channel marker.

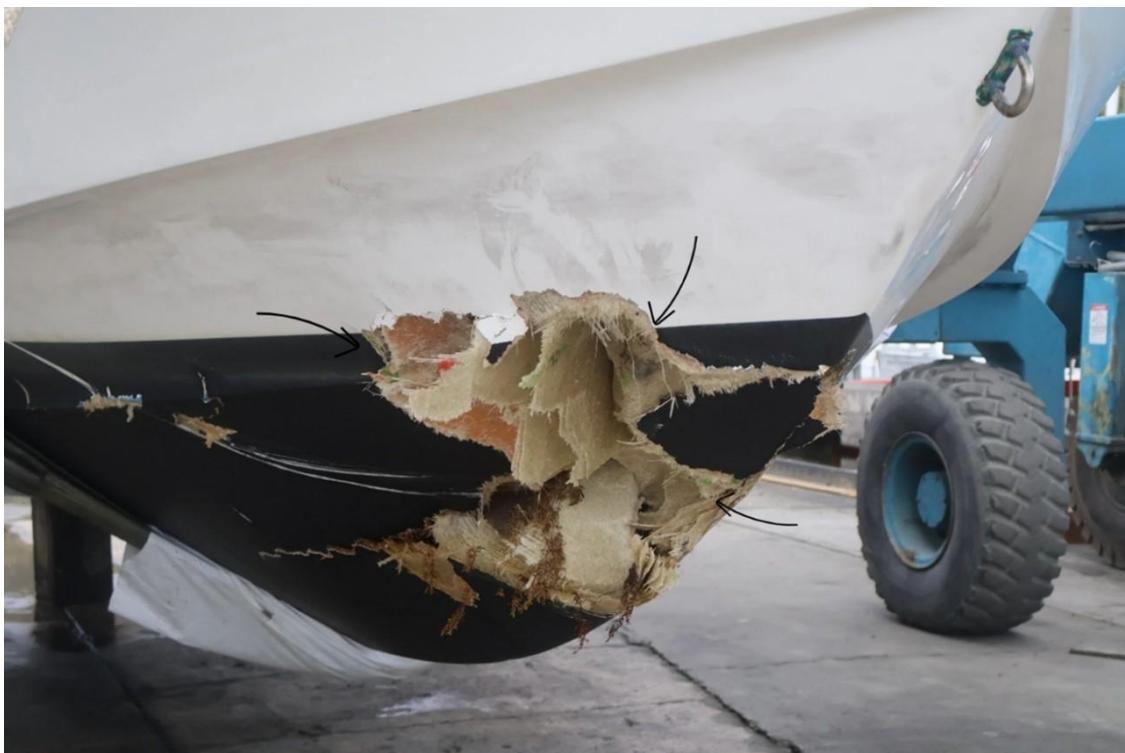
Figure 10: Green paint transfer observed on damaged areas of the hull.

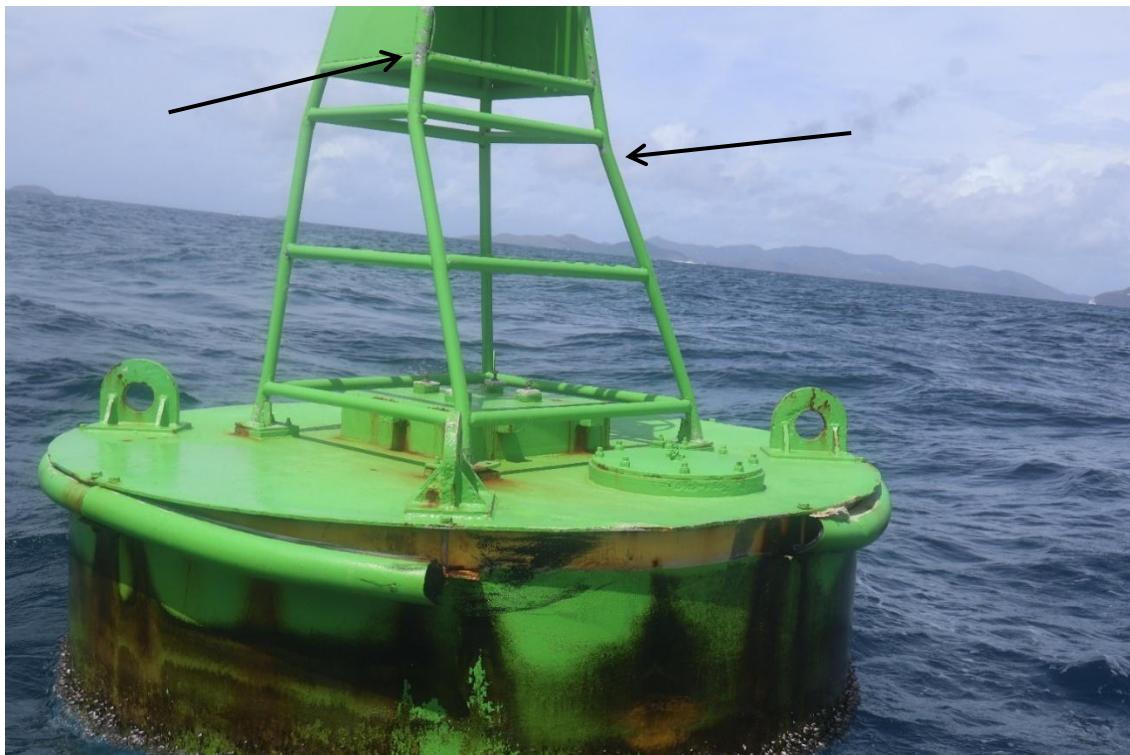
The buoy sustained structural deformation to the upper frame, abrasive grazing, and transfer of fibreglass fragments, consistent with high-energy contact from the collision. The damage pattern suggests the vessel's bow or upper hull made direct impact with the buoy's upper cone and frame before deflecting away. The incident resulted in material transfer, paint displacement, and metal bending, but no loss of buoyancy or total structural failure.

Figure 13: Bent frame due to impact

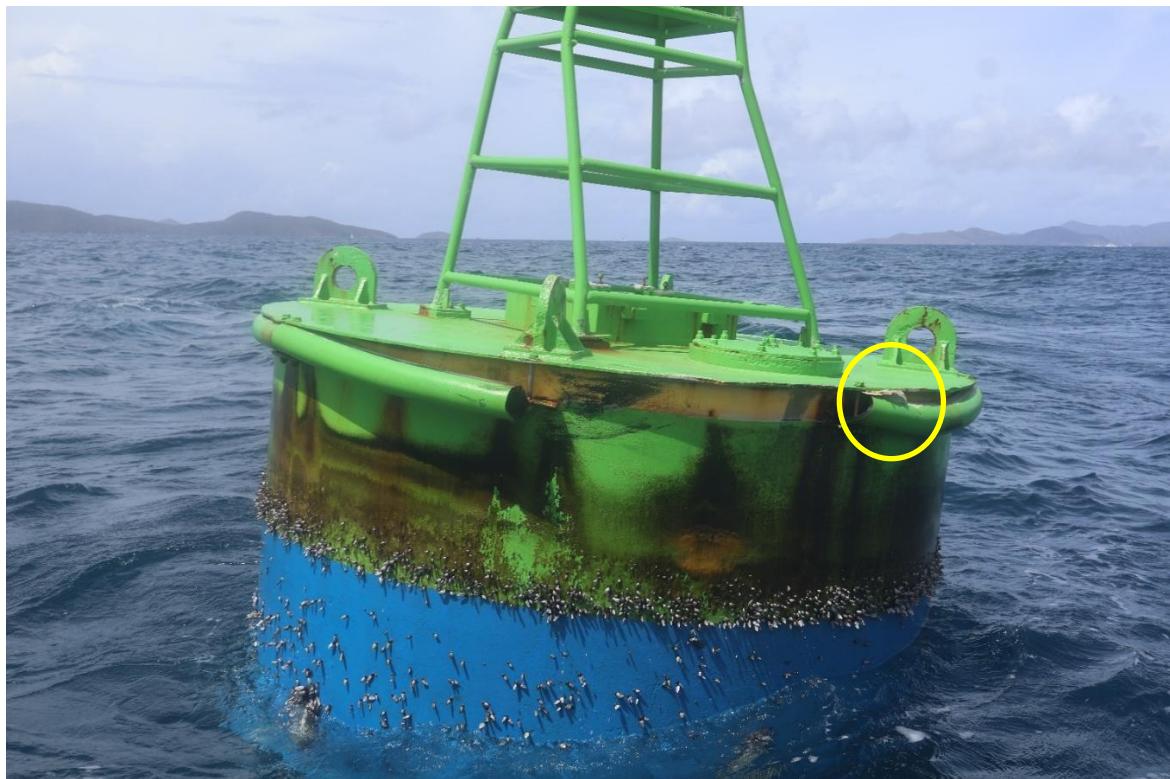
Figure 14: Pieces of fibreglass were observed stuck in the protective fender of the lateral channel marker's hull.

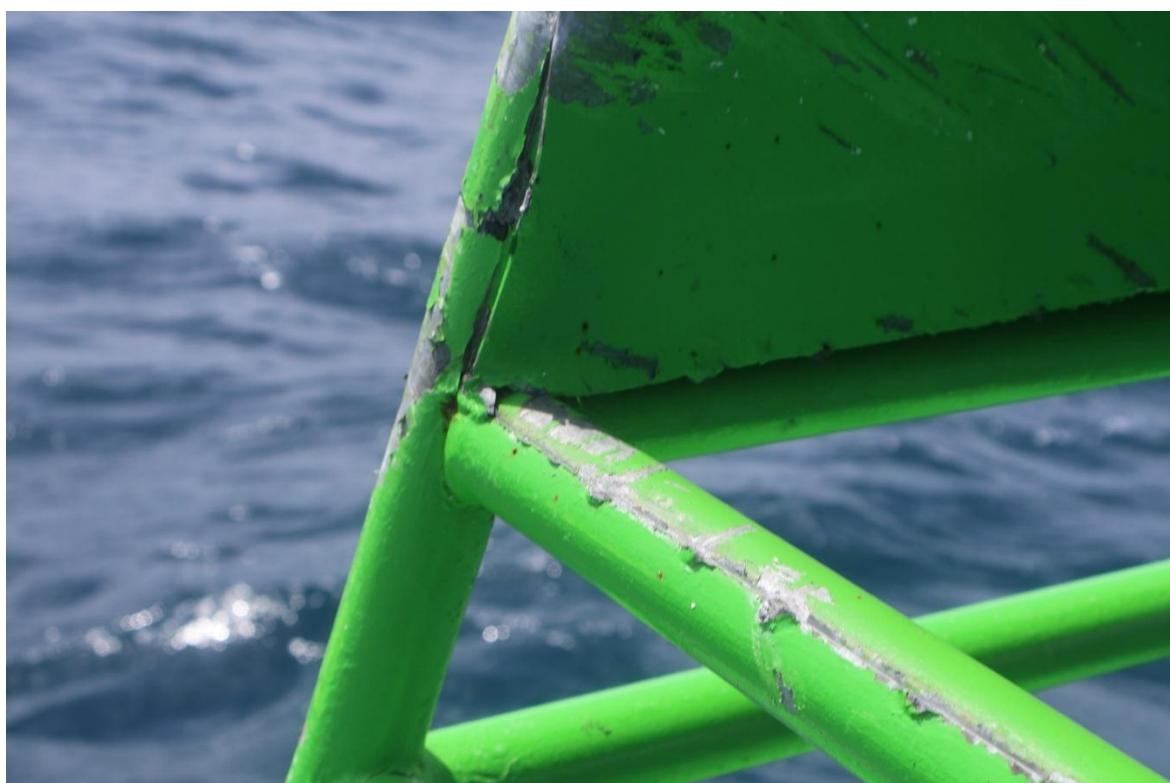
Figure 15: Grazing observed on the upper section of the lateral channel marker.

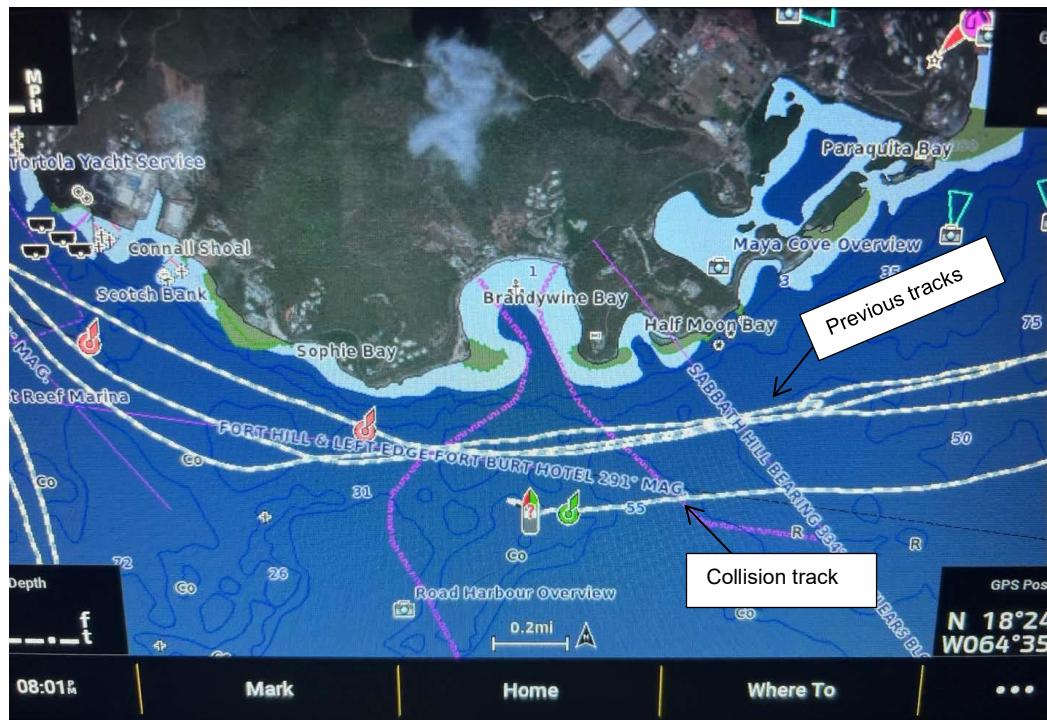
The captain's account indicated that the same tracks were used to and from the incident. Upon analysis of the electronic chart-plotter, separate tracks were observed to and from on the day of the incident. The data recorded on the night of the incident shows a single, distinct track leading directly toward the green lateral buoy, diverging from the usual inshore paths. This single route represents the vessel's actual course during the occurrence. It demonstrates a direct approach that placed the vessel on a potential collision path with the buoy, differing noticeably from the standard transit tracks visible on the chart.

Figure 17: GPS Chart-plotter tracks showing previous tracks used and the single track used on the night of the accident.

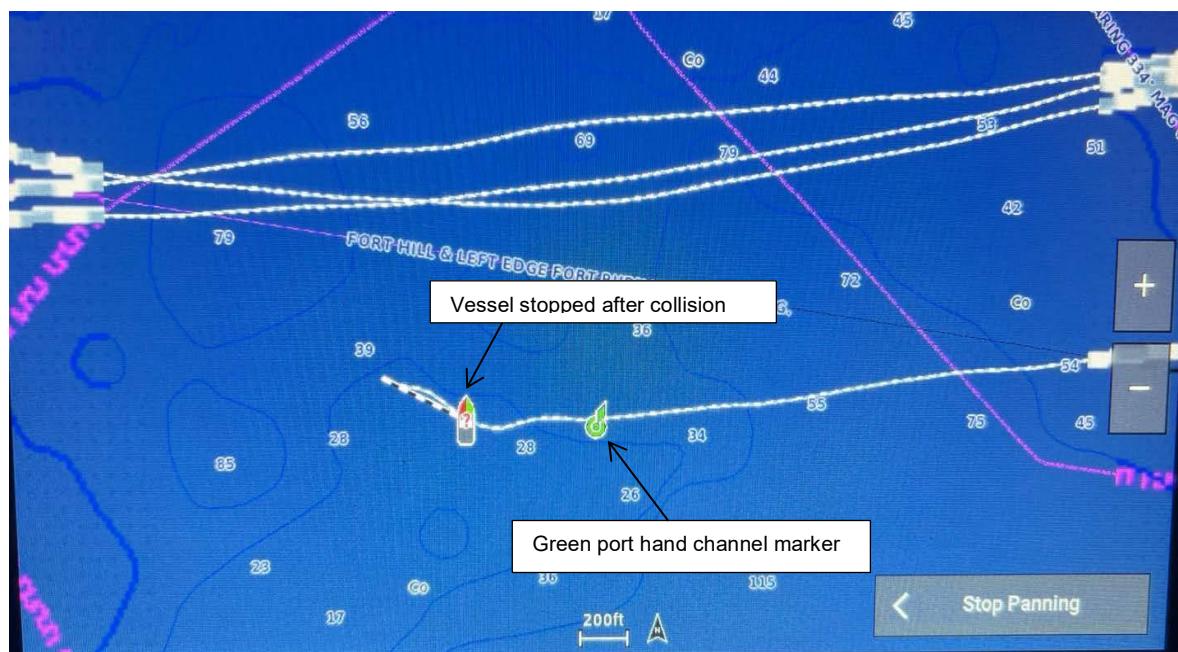
The GPS data also revealed that the vessel maintained a steady cruising pace of 26-28 knots with a consistent west-to-west-northwest heading. The track showed an almost straight line consistent with speed and heading for about 2.8 nautical miles. At 8:45 p.m., the vessel's speed decreased within three seconds by 11 knots, indicating that the vessel collided with the green port-hand channel marker at this time.

Figure 18: Chart-plotter tracks showing the vessel passing directly through the watch circle of the green port hand lateral channel marker.
