# SAFETY ACCIDENT REPORT

## **Safety Investigation Report on the Collision of MV Mojaito, Road Harbour, Virgin Islands 26<sup>th</sup> July, 2025**

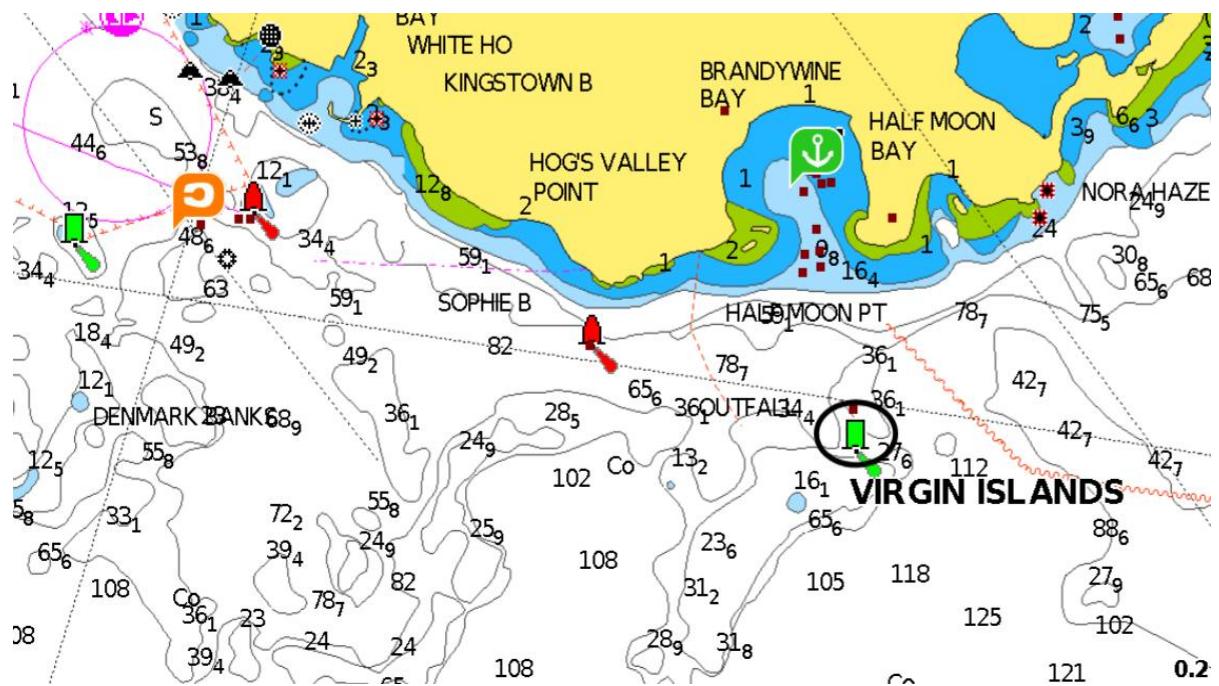
Figure 4: Extract from Navionics showing green steel lateral buoy (circled) z

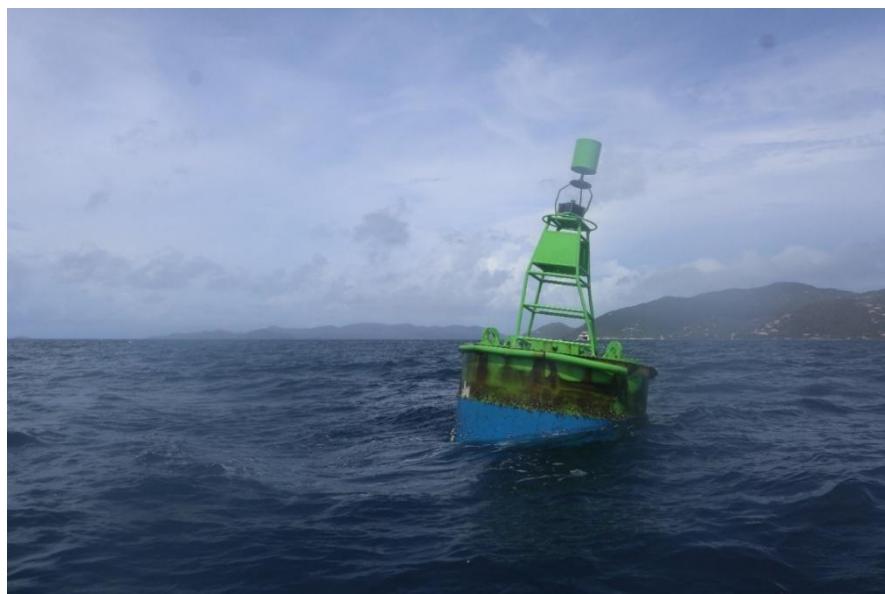
Figure 11: Green lateral buoy (portside channel marker)

The buoy sustained structural deformation to the upper frame, abrasive grazing, and transfer of fibreglass fragments, consistent with high-energy contact from the collision. The damage pattern suggests the vessel's bow or upper hull made direct impact with the buoy's upper cone and frame before deflecting away. The incident resulted in material transfer, paint displacement, and metal bending, but no loss of buoyancy or total structural failure.

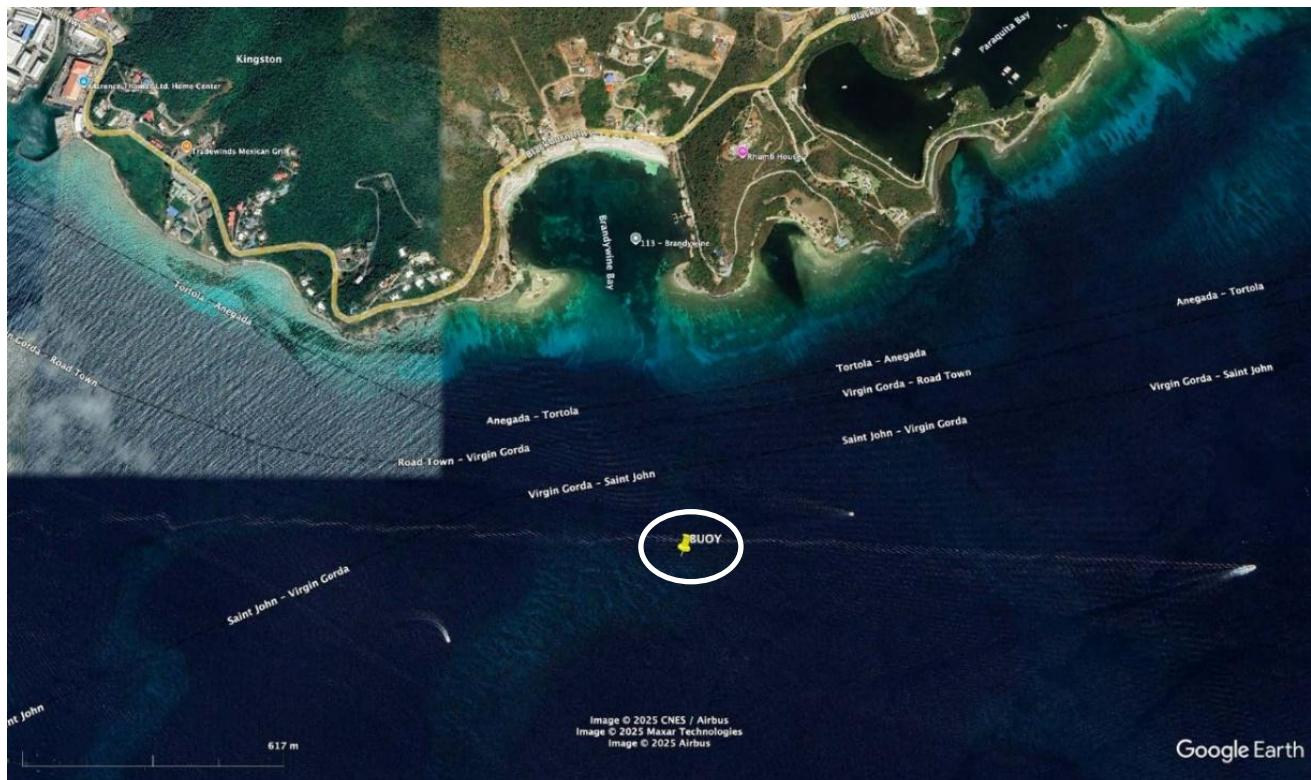
The green lateral channel marker is positioned south of the entrance of Brandywine Bay, Tortola, at an anchored position of 18°24.406'N, 64°35.009'W. This buoy marks the portside channel marker of the channel for large vessels entering Road Harbour from seaward. The channel marker aligns with the IALA Region B buoyage system used throughout the Virgin Islands.

Figure 12: Extract from Google Earth showing the location of the portside lateral channel marker.

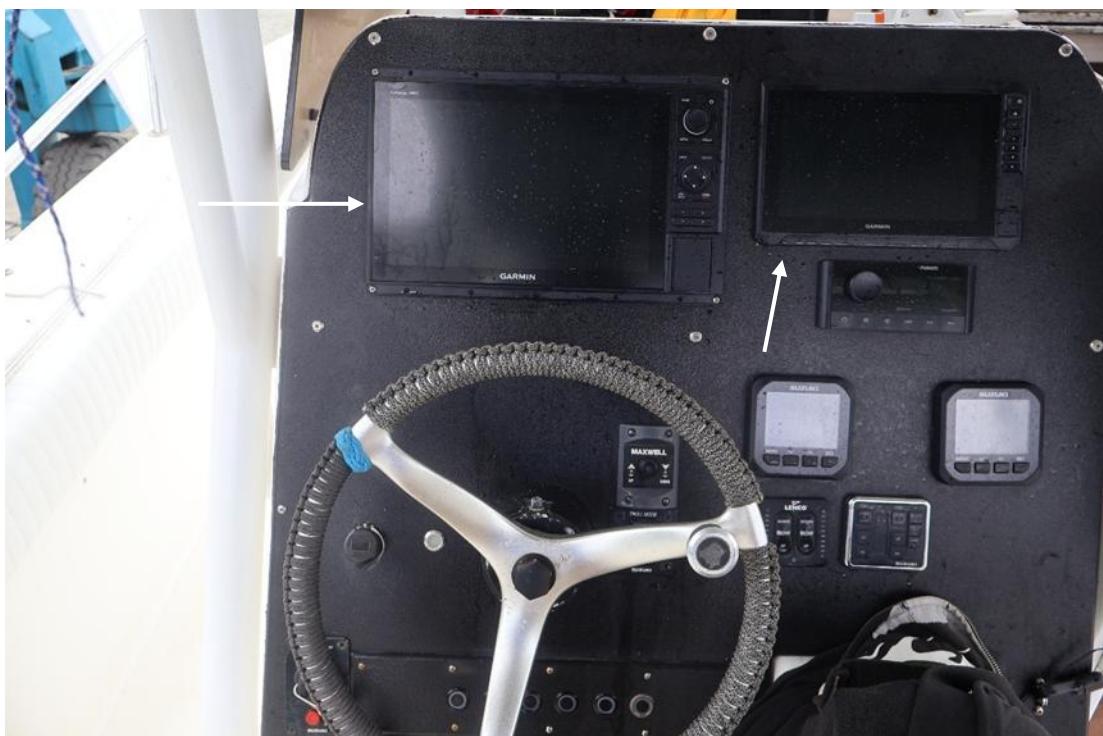
Three Garmin chart-plotters were recovered for inspection. The first, a Garmin GPSMap 1242sv, was found to be water-damaged and inoperative. The second device, a Garmin EchoMap UHD 74CV, was functioning but contained no relevant data saved. The third chart-plotter, a Garmin EchoMap UHD2 94SV, was operational and provided GPS track data that matched the incident time and position. The recovered data confirmed that the MV Mojaito was travelling at a near-constant speed and heading, consistent with the captain's reported course, thereby corroborating the physical damage pattern and forensic evidence.

Figure 16: Chart-plotters observed on console.

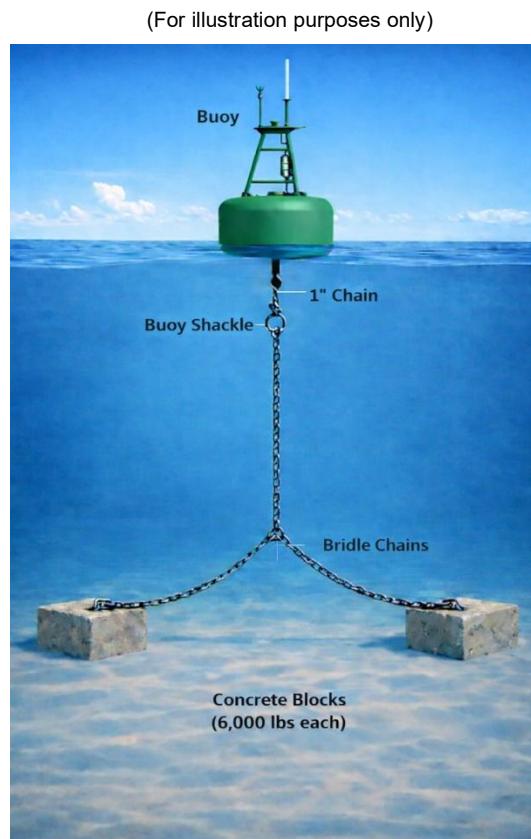
Figure 20: Image depicting a similar build from the seabed up to the surface of the green port hand channel marker.

The green lateral channel marker south of Brandywine Bay is maintained by the BVI Ports Authority, which subcontracted Commercial Dive Services for maintenance. According to the maintenance and installation records from the BVI Ports Authority and Commercial Dive Services, the green lateral channel marker at Brandywine Bay was built using the following materials:

- Chain -Approximately 60 feet of one-inch, long link chain.
- Concrete blocks (Anchors) -Two concrete blocks, each weighing 6,000 pounds.
- Shackles -Five one-inch shackles to attach the blocks to the chain and channel marker.

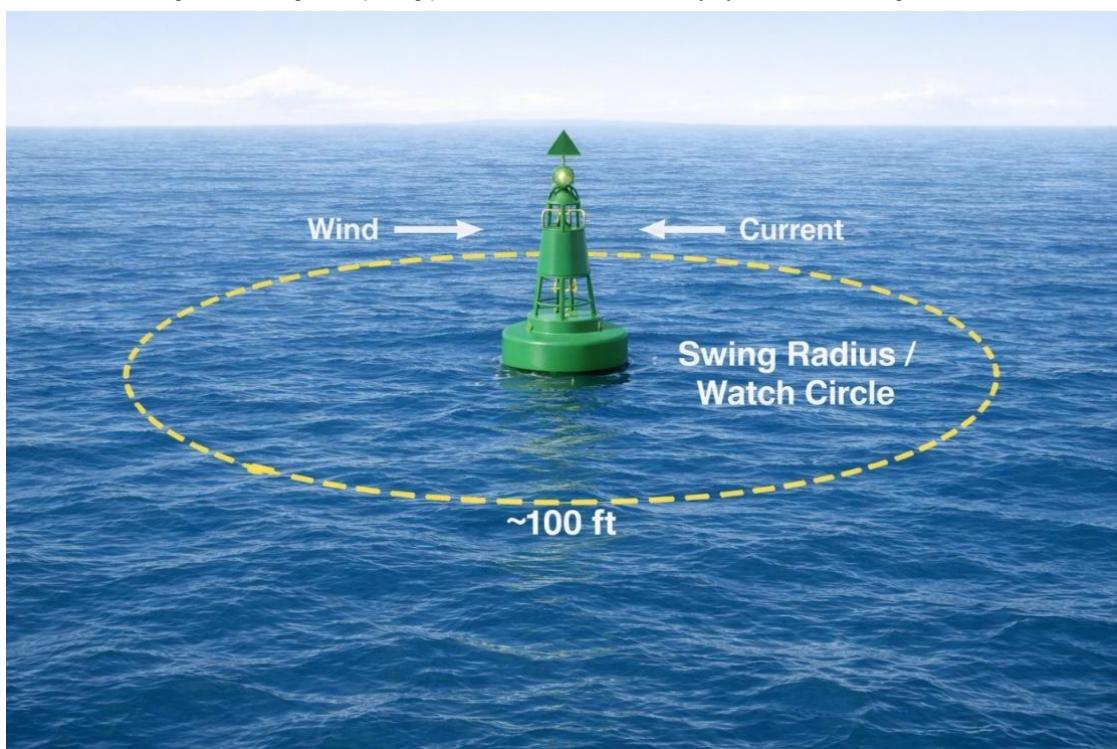
Figure 21: Imagine depicting potential movement of a buoy system with a swing radius

The watch circle of a lateral channel marker is the area on the water's surface where the buoy can move due to wind, current, wave action and tide, while still secured to the seabed. This area is determined by the effective length of the mooring system, which includes chain, rope, and swivels, as well as the vertical distance from the seabed to the buoy, taking tidal range into account. The radius of the lateral channel marker is estimated at 100 feet.
